Tunnel at Tegel Airport Berlin (motorway A111)

general renovation and technical and safety retrofit

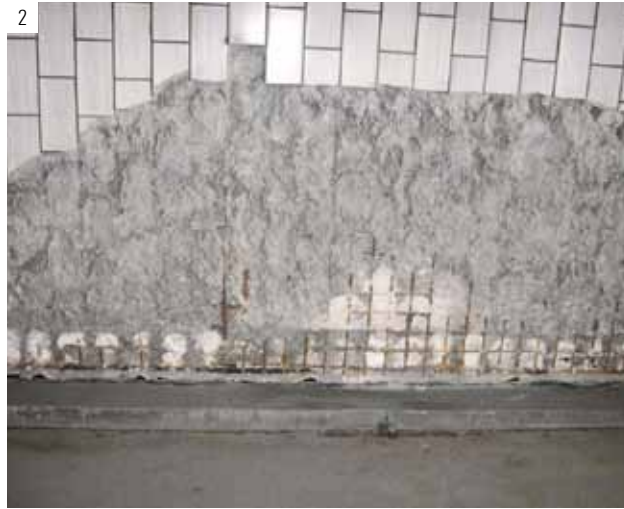
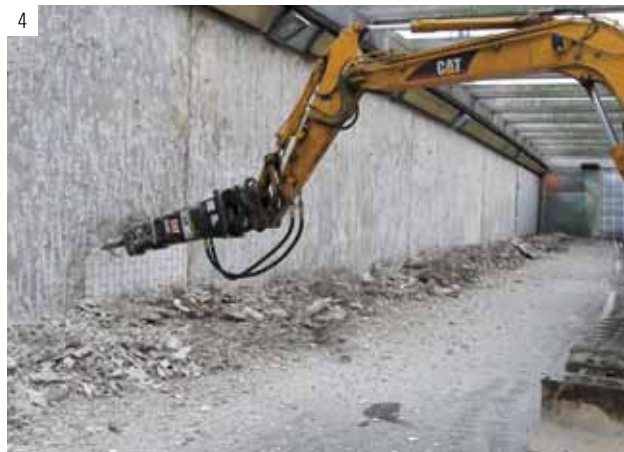
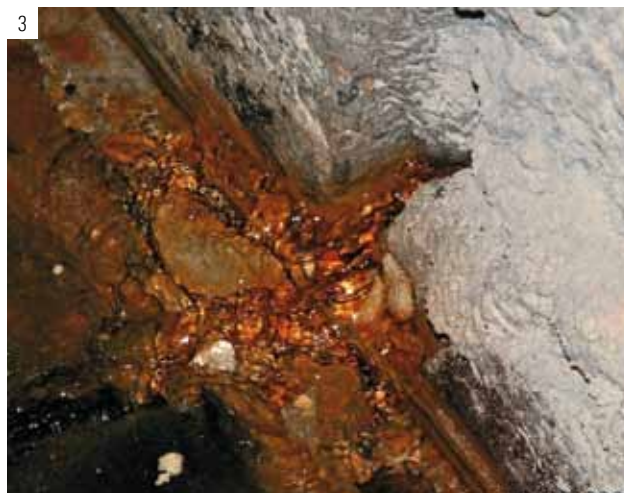
During utilization for more than 25 years, severe damages in the area of the bloc joints occurred. Especially in the winter, partial close-offs of some lanes were necessary as groundwater infiltrated by the damaged bloc joints which then froze. Moreover, at the joint edges heavy chippings appeared because of the contraction joints.

Due to piston effect caused by traffic, temperature variances between +25° to -20° C occurred in the tunnel throughout the year resulting in movements of the bloc joints. In the context of cause studies in 1990 and 1991, measures of the joint movements were taken. The results showed maximum joint openings of the 30 m bloc joints reaching up to 20 mm. The bitumen sealing layers on the outside were unable to compensate durably such movements in the area of the contraction joints and failed on numerous joints. The walls in the tunnel were covered with ceramic tiles in thick mortar. During use of the tunnel, large areas came off the walls because of infiltrating water and other causes, or hollow spaces formed behind them. The protecting cover required for fire safety was not present in this area.

1 Cavity behind ceramic wall lining
 2 Dismantling to the old tunnel's bare concrete
 3 Leakages in the block joints

The first construction phase consisted of completely removing the core of both tunnel shafts. All operation and traffic installations were taken out before removing the core. Then, the lanes were demolished completely including all sealing layers and emergency paths. Removal of the core finished with the complete demolition of the existing ceiling cover and gunned plaster spread in very uneven layers. During conversion, contaminated material (e.g. tile mortar, asbestos tubes underneath the deck) had to be disposed of; to do so, a special work container unit had to be installed on site.

Infiltrating groundwater in the bloc joint areas was one of the most essential constructional damages which led again and again to restrictions of the tunnel's operation. Renovation of the damaged areas from the outside was not feasible as this would have entailed partial shutdown of Tegel Airport as well as extensive groundwater lowering. Both measures had to be excluded on account of economical reasons and permissions.

The evaluation of damages showed that water was infiltrating in the bloc joint areas. Water carrying cracks in the base slab or the outer walls seemed not to be evident. The existing surface sealing in connection with reinforced concrete constructions seemed not disturbed in its function, the core concrete of bottom and wall in good state; both were confirmed during renovation works. Renovation of the sealing layer on large surfaces (e.g. additional internal sealing with an inner shell) could thus be excluded during considerations for structural improvement of the tunnel shafts. A connection between the new joint sealing to be placed on the outside and the base slab (air side) to the outside bituminous sealing (underside) was not followed and was not achievable from a technical point of view. The main design focus was set on a durable concept of the new overhead joint formation of the bloc joints and the careful design of all constructional details. For the base area an expansion joint with a special transition to the elevated wall areas had been developed which comprised a 35 cm thick elastomeric joint tape at the inside which was integrated – nearly at the same level – through newly built upturned concrete edges along the joints in the base concrete. Parts of the base concrete on both sides of the joint had to be removed for construction of the upturned edges and a sufficient embedding of the joint tape

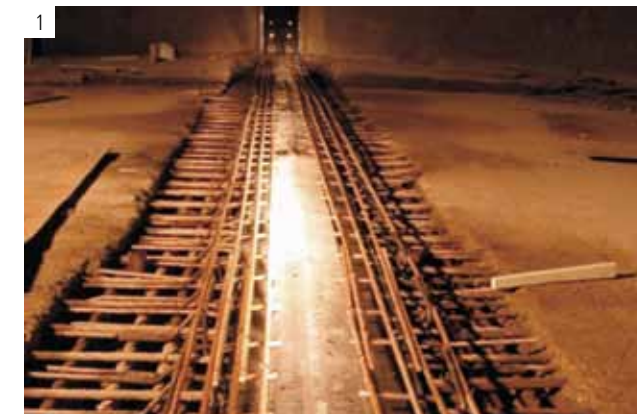
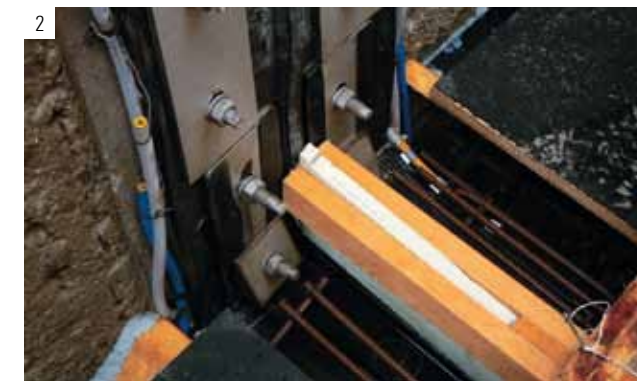
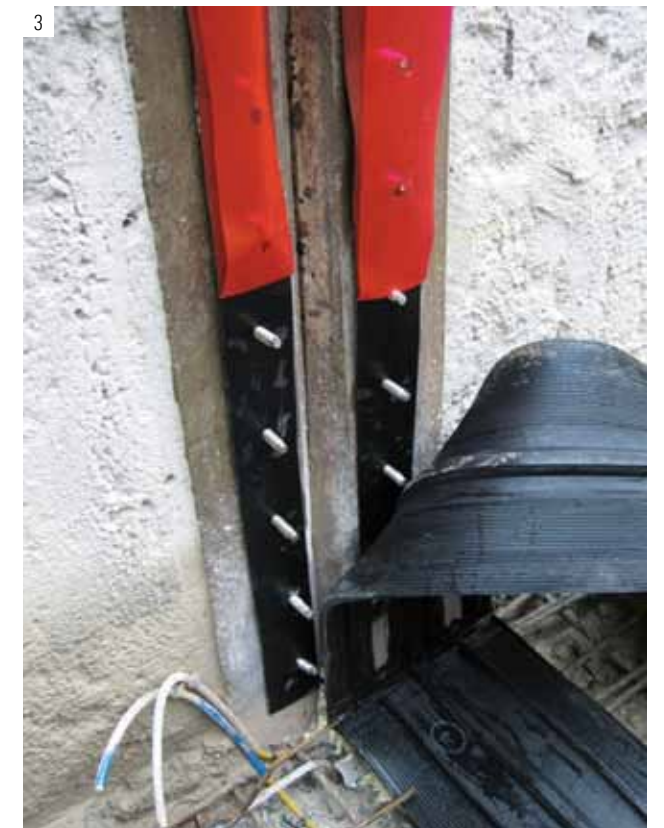
1+2 Posing and fixing of joint tape prepared in-situ and completion of reinforcement
 3 Adjusting and flanging of special construction at the transition floor – wall

by high-pressure water jet. Re-profiling of the demolished areas and the construction of the upturned edges were implemented with self-compacting concrete of quality C30/37. For construction of the external geometry of the upturned edges, a cover structure with funnel-shaped concrete case at the highest points of the transverse slope was planned analogous to the joint to be constructed.

To better evaluate the planned joint construction and constructional feasibility, already in the draft phase a 1:1 model was built which showed the transition floor to wall. Moreover, the services

to be delivered included the construction of two model joints to be built under 'in-situ' conditions. By constructing the model joint, the determined work stages and the suitability of the self-compacting concrete were tested in practice. At the cutting surfaces, the cavity-free assemblage of the concrete and durable integration of the joint tape was put under examination.

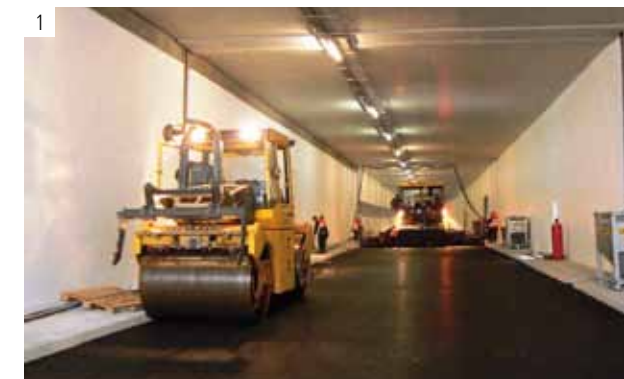
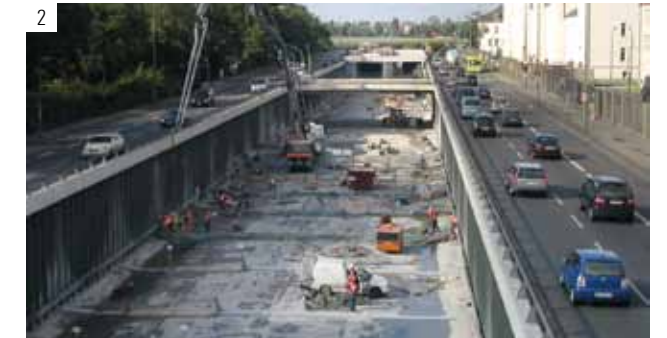
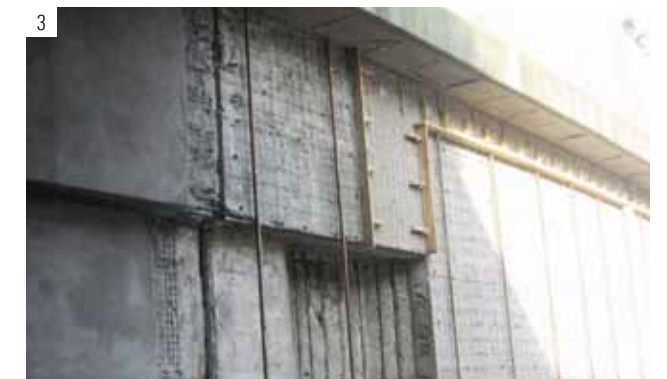
- 1 New carriageway structure incl. sealing
- 2 General renovation in the trough area
- 3 Constructional fire protection at wall areas by a 6-cm-thick shotcrete layer with galvanized reinforcement mat

After preparation of the undercoat by high-pressure water jet and concrete renovation works of the external and middle wall areas, a double layer of shotcrete was applied to damaged areas in accordance with ZTV-ING (German additional technical conditions of contract for engineering structures) at a minimum thickness of 6 cm. Onto the shotcrete layer with grains 0/8 mm and a compressive strength of C30/37, gunite mortar was applied in order to have an even surface of 5 mm on 4 m slats. To have the necessary fire resistance category, the layer was reinforced by a galvanized mat Q131.

The niche surface of the external wall for cable routes was formed by shotcrete. To obey minimum required dimensions, a 3 cm shotcrete layer with grains 0/4 was applied. The fire protection reinforcement was assured by galvanized mats N141. After

The base slab of the tunnel shafts was carefully cleaned by shot peening. Then damages and cracks were assessed and renovated according to indications of the construction management by crack grouting and concrete replacement. Further works were accomplished according to ZTV-ING with an epoxy resin foundation and a welded bitumen sheet which was strengthened along the future emergency paths with stainless steel laminated welded bitumen sheets and glass fleece bitumen sheets. At the transition base slab to wall a polyurethane liquid plastic sealing was used including a supplementary connecting layer at the 20-cm-wide transition between liquid plastic sealing and welded sheet. To protect the sealing, a 4-cm-thick mastic asphalt coating was applied; on top of it an asphalt binder with variable height (4 – 8 cm) was set as intermediate layer as well as 2 layers of stone mastic

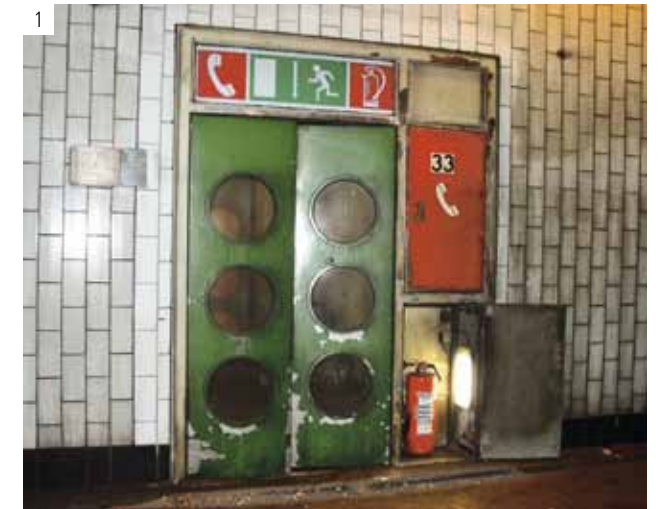
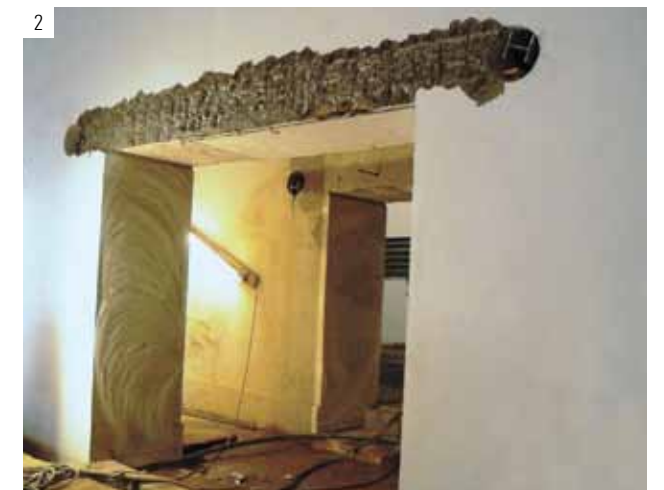
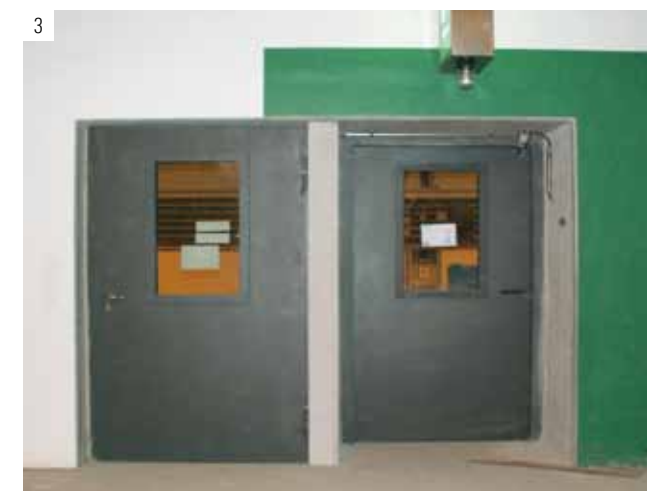
1 Old operation and traffic technical installations, emergency doors
2 Widening of emergency doors
3 New emergency doors in the middle wall between tunnel shafts

Remote monitoring by the control centre is assured by 50 individually controllable video cameras in the tunnel walls. The existing 12 escape doors, at a distance of 130 m in the outer wall and in the middle wall, were enlarged during conversion works and provided with F90-equipment. The already

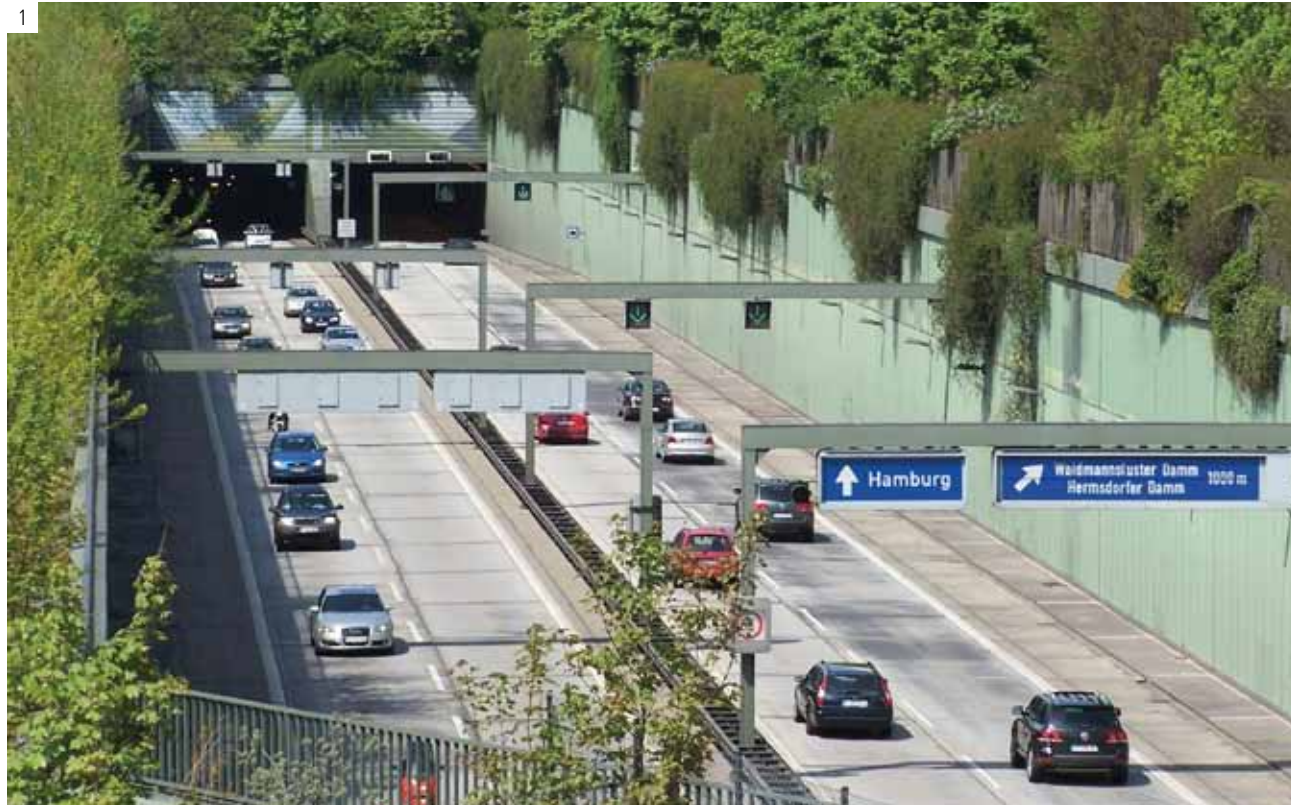
- 1 Initial situation trough and tunnel portals, area south
- 2 Emergency route north 1 during construction, width 1.5 m, wall lining left F 90
- 3 Final state
